**OTC 24724-MS**

## **Stop Erosion at the Well Head on Fractured Wells**

Trina Dreher, Alex Biley, Phillip Tuckett, Process Group Pty. Ltd.

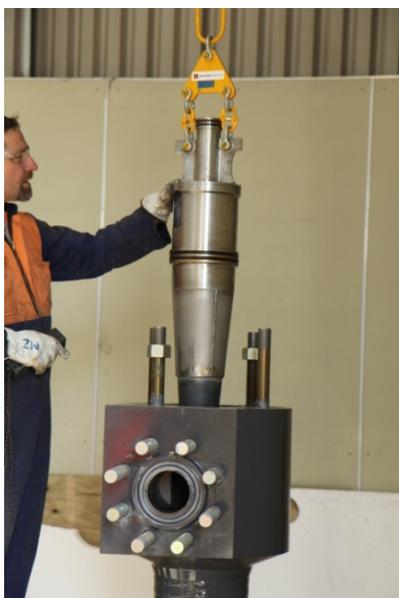
Figure 1: Desander cyclone being lowered into containment vessel.

Due to the very high pressure rating manufacture of the pressure vessels required an unusual approach. Pressure vessels are typically manufactured from rolled steel plate or pipe material however, steel plate of the required thickness could not be rolled to the small diameters required to house the cyclone while pipe material is not commercially available with the wall thickness required to meet code requirements. Therefore, both the Desander pressure vessel and the Accumulator pressure vessel were custom designed to be fabricated from machined steel billets. The machined vessel parts were specifically designed to incorporate the required nozzles into the vessel heads and shell which could then be bolted together to minimise welding. Essentially, a solid steel cylinder was bored out to create a hollow middle where the desander cyclone liner could be installed and a second solid cylinder bored out to create the accumulator vessel. Figure 1 shows the desander cyclone liner being lowered into its pressure vessel machined from a solid steel billet. Extensive Finite Element Analysis (FEA) was performed to determine the stress profiles of the vessels and the required wall thickness and shape of each portion of each vessel; an example is given in Figure 2. An additional challenge was attaching the vessels to each other and to the process lines as methods such as standard flanges and clamp locks were deemed unsuitable due to material, weight, mechanical, and/or cost constraints. Therefore, Process Group designed custom flanges to fit within the aforementioned constraints as well as meet all process and mechanical specifications. The final design involved the unusual design of bolts being directly screwed into the vessel shell wall to minimise welding.

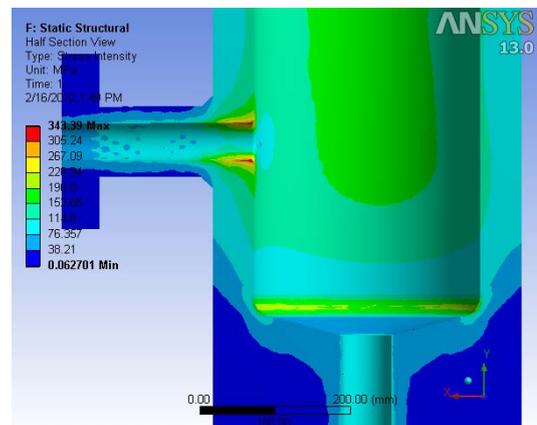
Figure 2: Finite element analysis image from desander accumulator vessel

To facilitate online removal of accumulated sand, a separate accumulator vessel, where separated sand settles, was installed below the desander vessel. The accumulator vessel can be isolated from the well head desander, depressurised and safely emptied while the desander vessel remains online. A small sand accumulation area is retained in the lower portion of the desander vessel so that sand removal can continue while the accumulator vessel is isolated. A water flushing system is also incorporated in the accumulator vessel to aid sand removal from this vessel.

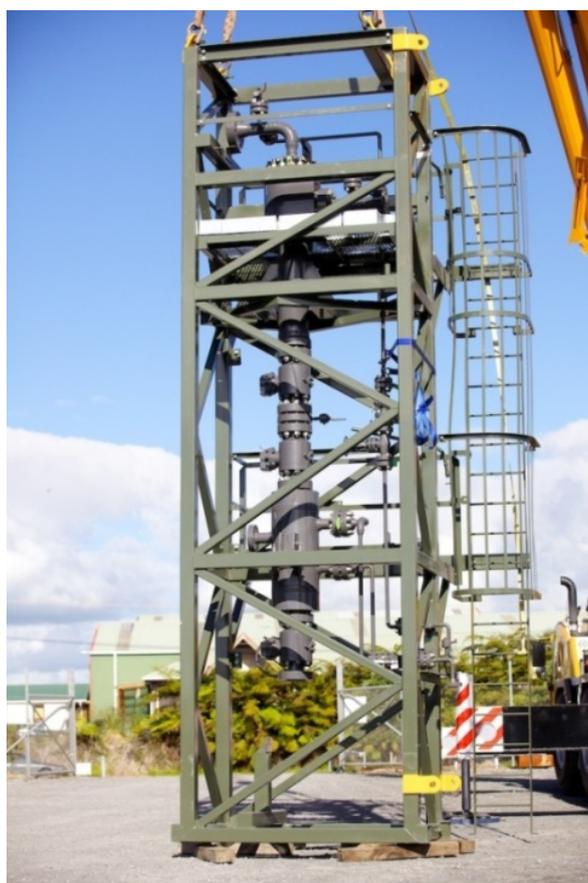
Figure 3: Completed well head desander package

The completed well head desander cyclone system is shown in Figure 3. Due to the compact nature of the desander cyclone package and its low maintenance requirements, it is equally applicable for offshore or onshore applications. The desander system was installed on the original well and as it performed so successfully it was also installed on additional wells in the Mangahewa field. The original system has been in operation for over ten years and has not required any substantial maintenance nor suffered any significant erosion during this time. In addition, few solid materials have been observed in downstream equipment. The desander systems installed on subsequent wells have been in operation for over a year and have also shown no signs of erosion confirming the efficiency and integrity of the process and mechanical design.
